# Manhole Inspection Summary

Manhole # S13U\_\_003MH

Insp Date: **1/9/09 10:18 AM**

**Location** Address: **1100 Wilso Dr.**

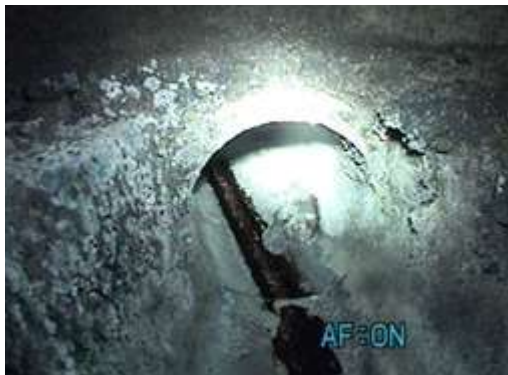
Defect 7

☒ **Deteriorated**

channel deteriorated

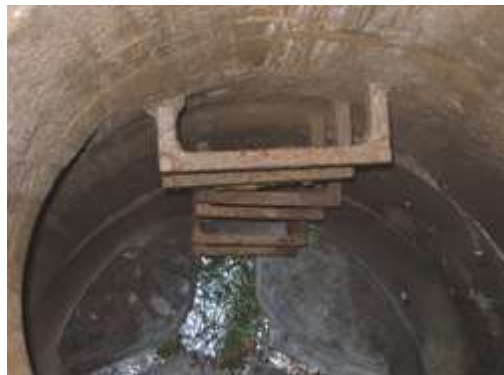
Defect 6

☒ **Corroded**

steps corroded

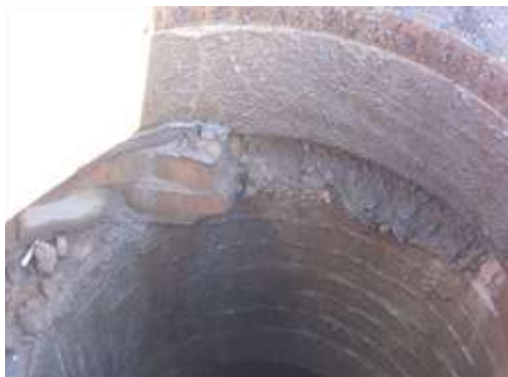
Defect 5

☒ **Cracked**

☒ **Loose Brick**

☒ **Deteriorated**

☒ **Mortar**

chimney cracked, loose bricks,  
deteriorated, infiltration at mortar

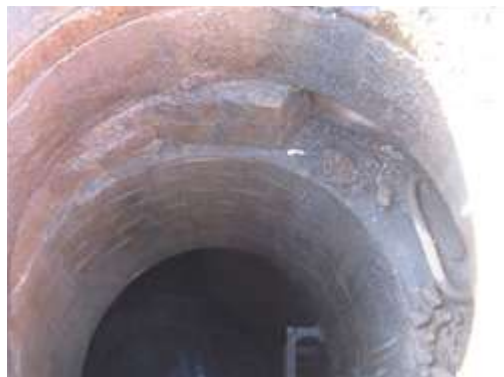
Defect 4

☒ **Leaks**

☒ **Joint**

frame infiltration at cover, chimney  
infiltration at frame joint

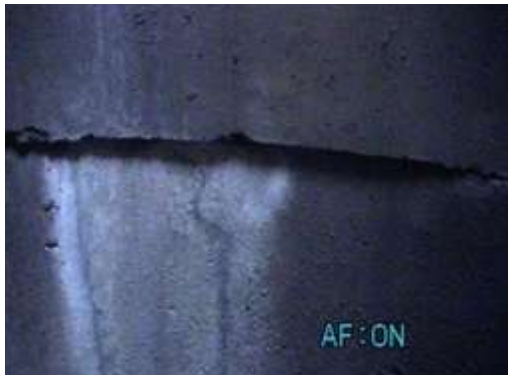
Defect 3

☒ **Joint**

corbel infiltration at chimney joint

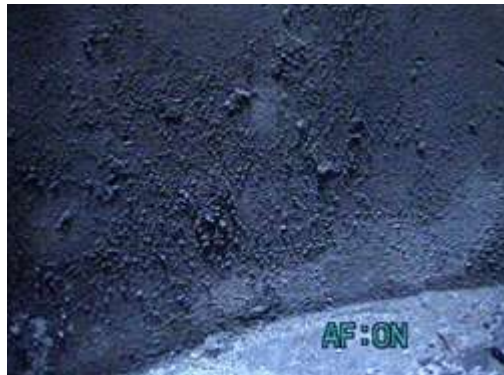
Defect 2

☒ **Wall**

barrel infiltration at wall

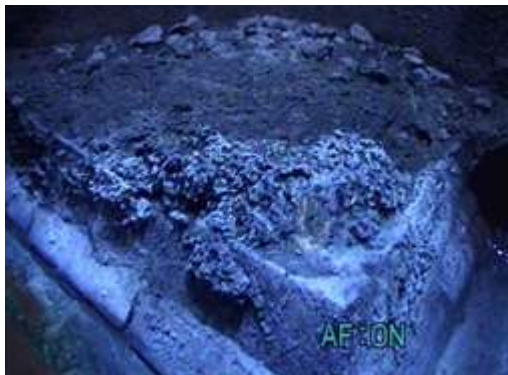
### Defect 1

☒ **Deteriorated**

☒ **Debris**

bench debris
